Annual Inspection Report

Courtland Airport

ANNUAL INSPECTION REPORT

COURTLAND AIRPORT
COURTLAND, ALABAMA

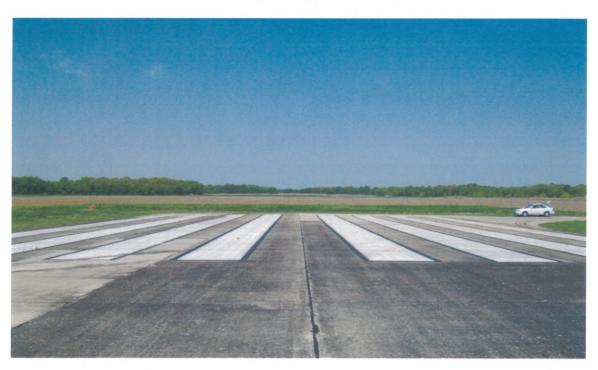
Photo #1 - Runway 13 Approach/Departure Path

- Runway 13: No obstructions (See Photo # 1)
- Runway 31: No obstructions (See Photo # 2)
- Runway 17: The approach and departure path for runway 17 was inspected and found to meet state licensing standards. However, trees identified as Tree # 1 and # 5 violate the 20:1 approach slope within limits of the FAA's Runway Protection Zone (RPZ) and a tree identified as Trees # 2, # 3, and # 4 if allowed to continue to grow will also eventually penetrate the FAA's RPZ (See Photo # 3, and Appendix 2).

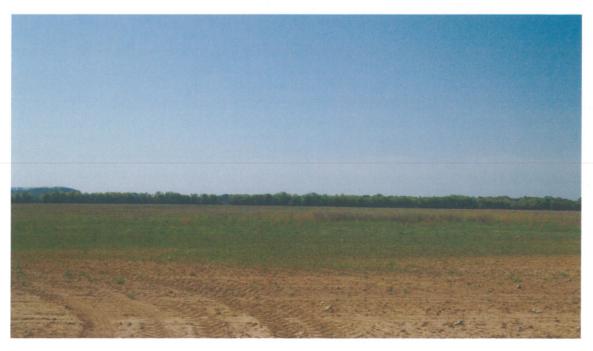
Photo # 4 - Runway 35 Approach/Departure Path

• Runway 35: No obstructions (See Photo # 4).

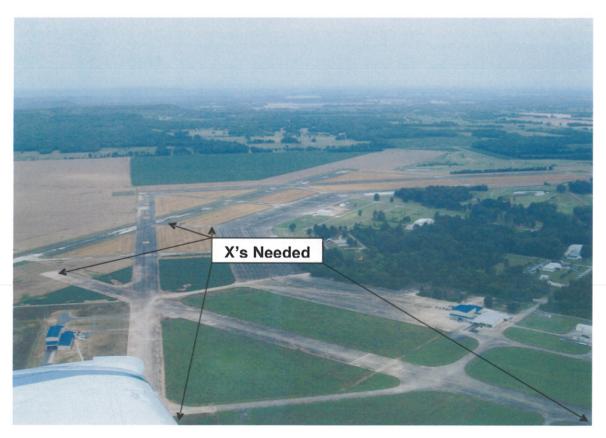
The airport markings were in good condition; however all closed runways and taxiways are not marked as closed with yellow X's.

In accordance with AC 150/5340-1J, yellow X's should be painted on all closed runways, not just those on airport property. Yellow X's should also be painted on all closed taxiways at all entrances.

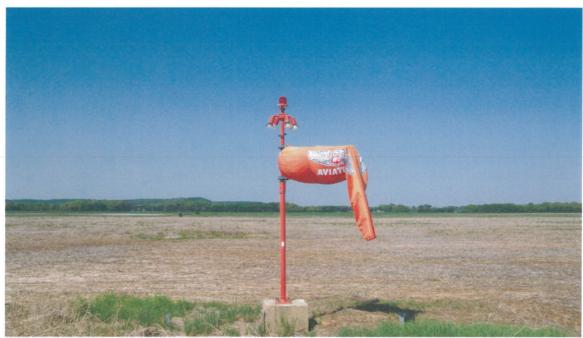
The wind direction indicator was found operational (Photo # 6).

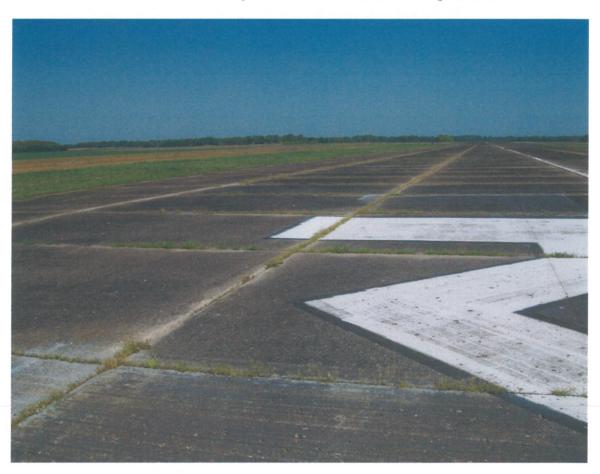
Photo #7 - Runway 35 Joint Cracks With Vegetation

• The surface of runway 13/31 and the apron are in good condition; however surfaces of 17/35 and adjacent taxiway surfaces are fare to poor. The runway surface of 17/35 is characterized by joint cracks with vegetation over 100% of the runway (Photo # 7) the adjacent taxiway has areas of scaling, with multiple slab cracks, as well as failed joints with severe spalling and potholes (Photo # 8).

Runway 17/35 will require joint cracks to be cleaned and sealed. Taxiway
will require joint cracks to be cleaned and sealed along with slab
replacement where there is extensive cracking and joint spalling and
complete reconstruction where necessary.

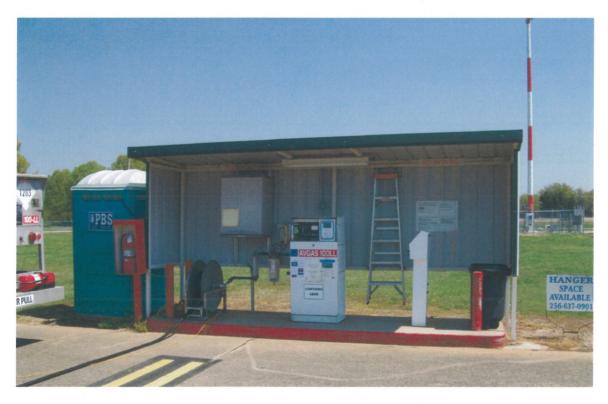
Photo #8 - Self-Service 100LL Fueling Area

• The fueling area meets the requirements established by the Alabama Department of Transportation. However, the State of Alabama Department of Agriculture and Industries may have additional requirements for fueling systems that were not considered during this inspection (See Photo # 8).
